LITTLE ROUND POND
LINCOLN, PENOBSCOT CO., ME.
AREA 75 ACRES

MIDAS # 2224

Surveyed - (September 1972)

Maine Department of Inland Fisheries and Wildlife

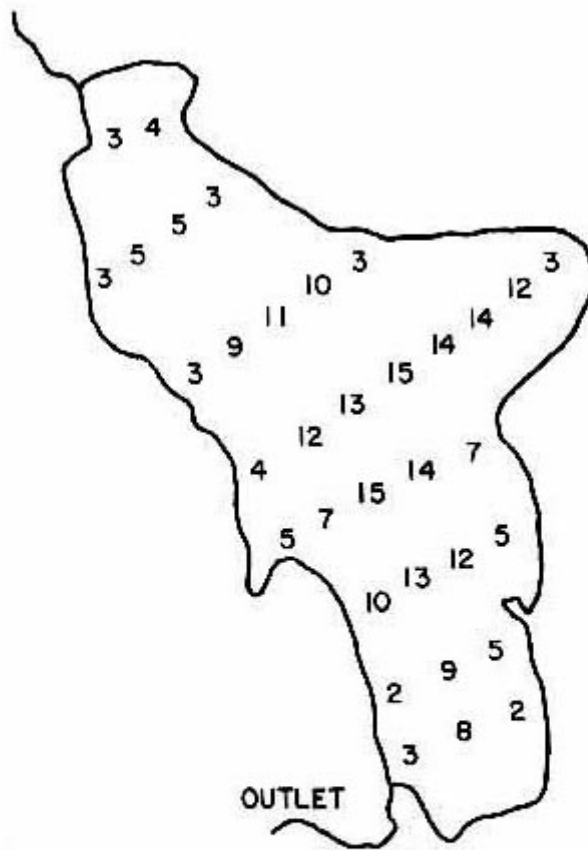
Maximum depth - 15 feet
